Deriving the Environmental Problems and Solutions Using Satellite Images Analysis around the Archaeological Mosque of Sultan Al-Zahir Baybars At Cairo, Egypt

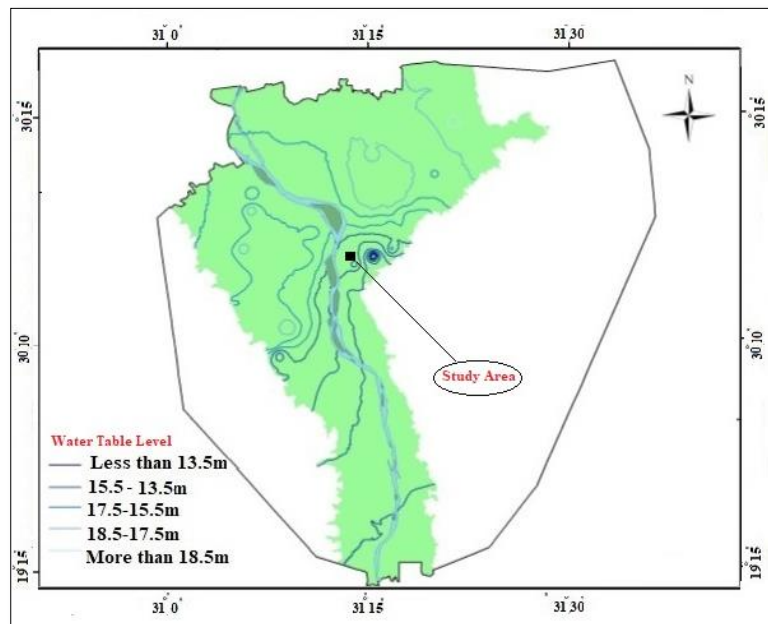
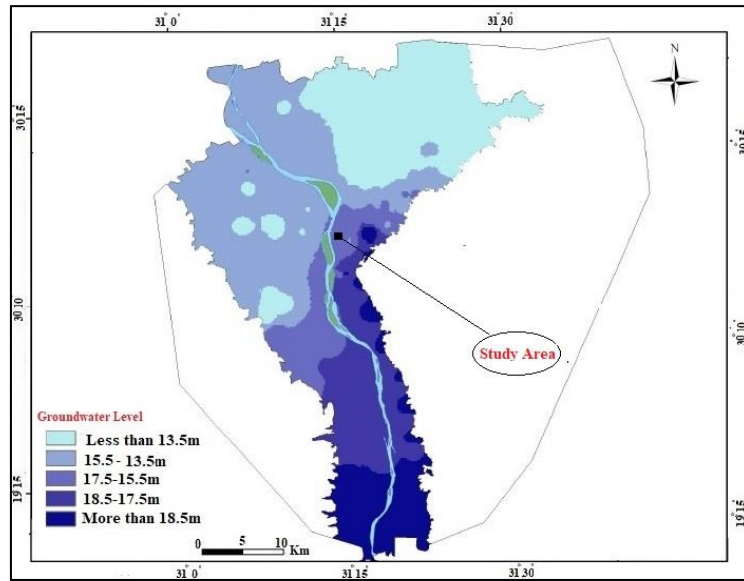
Fig. 7 Depth to water table of groundwater in the study area (a, and b).

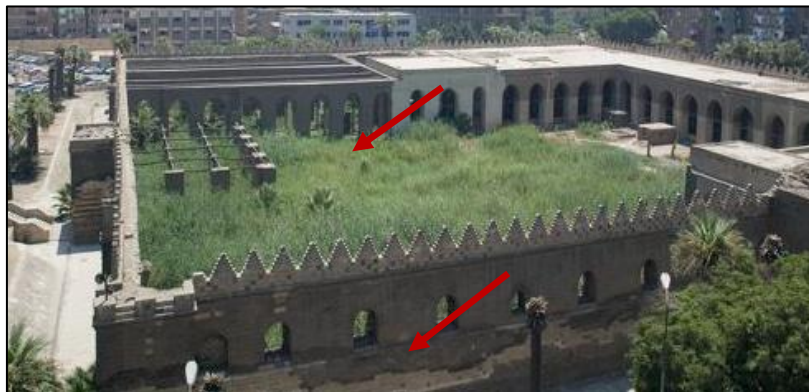
Fig. 8 Vegetation area is spreading interior of the mosque (a), and the deterioration in the Mosque as a result of the rising in the groundwater level through the studied area (b)

Many researchers worked by various methods to protect the archaeological sites in Egypt against the groundwater threats (Elfadaly et al., 2017, 2017, Lasaponara et al., 2015, 2016, Antoniou 1985, Moselhy 1989), threw light on historical background of AL-Fustat city (Hefny 1989, Attalla 1997), which investigated the groundwater problems in Old Cairo (Fig. 6). Besides the problems of the urban sprawling, the eastern part of the study area affected by the rising in the levels of the groundwater, this indicates that the recharge rate is high than the discharge of the Nile River. The highest levels of groundwater are in the Eastern part of great Cairo, as in Abbasia district, the levels of groundwater and that of the River Nile are affected by each other, especially after the building of the high dam (Zaghloul and Elbeih 2014) (Fig. 7a, and b). Urban encroachments, the geological, and hydrological setting have a great role in the archaeological damage (Fig 8a, and b).

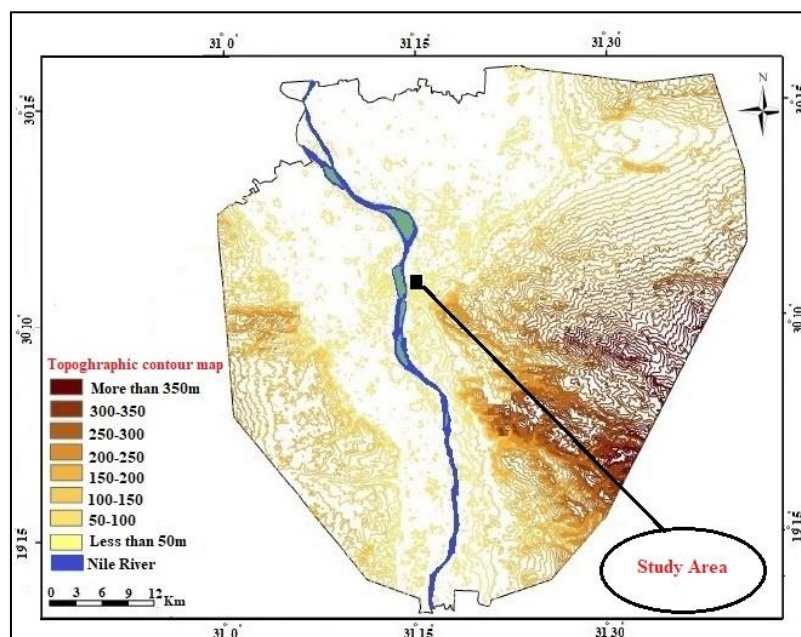
Fig. 9 Topographic contour line (a), and Digital Elevation Model of the studied area (b).

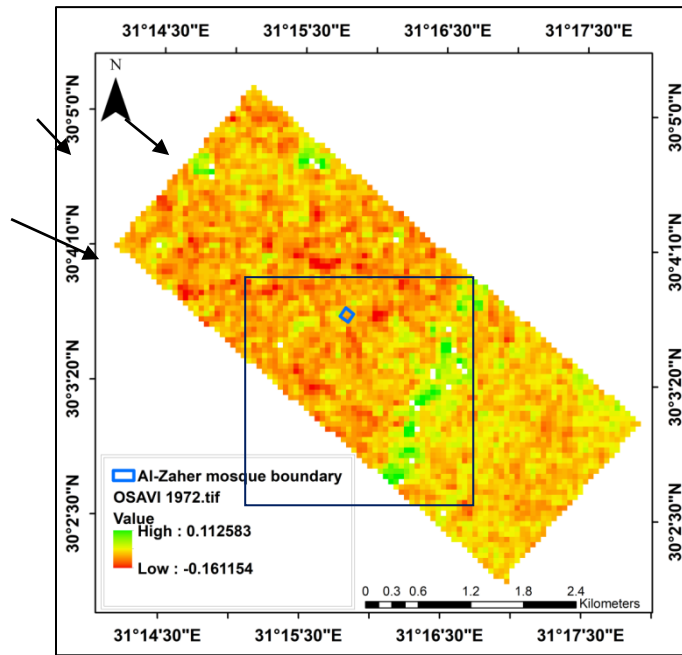
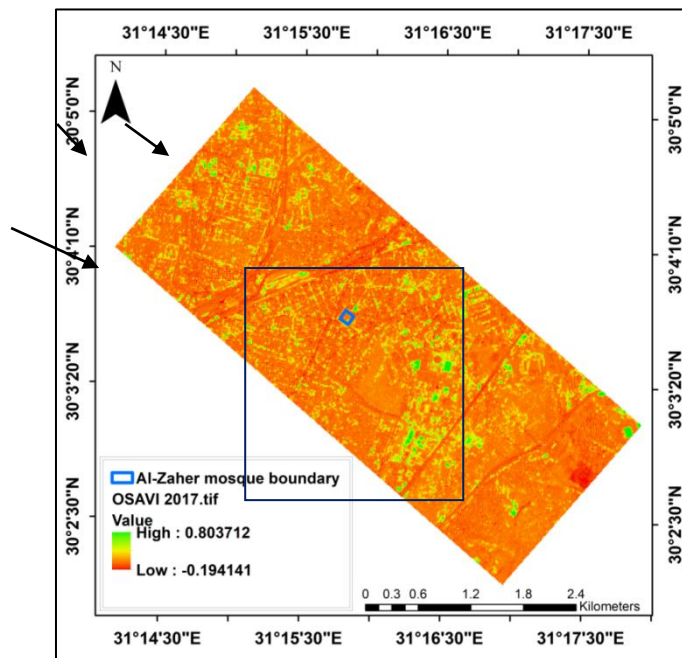
Fig.16 The OSaVI classification for the study area between 1972 (a), and 2017 (b).

Results indicated that there is a decrease in the changes between the two studied dates. These effects are very clear in the vegetation area around and interior of the archaeological area between 1972 and 2017 (Fig. 16a, and b).

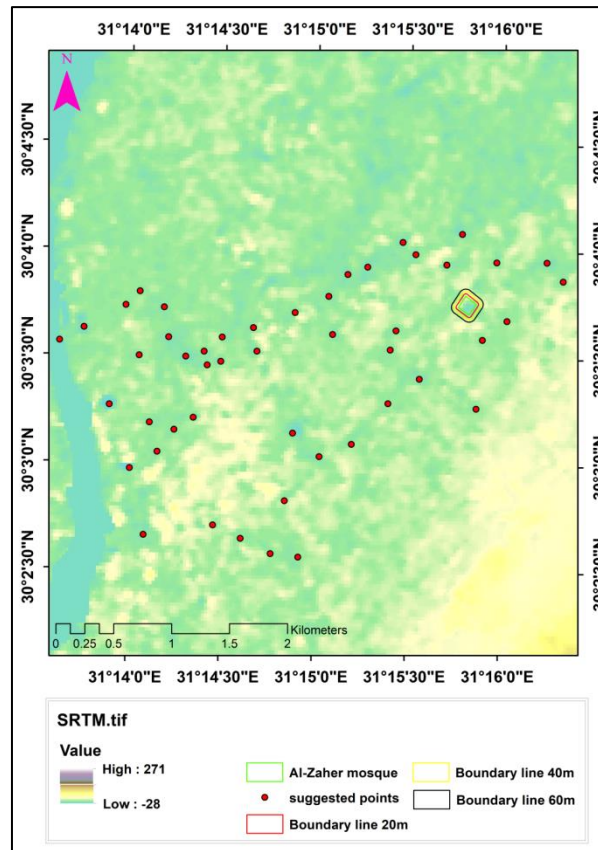
Fig.18 Suggested points for the proposed trenches around the study area.

Remote sensing and GIS techniques can be met by a Zonation System in Cairo that applies different management policies to different boundary zones. The distances have been chosen as a result of the environmental situation in the study area. The archaeological area must be surrounded by three areas. A suggested points for the proposed trenches around the study area have been carried out using the SRTM Dem (Fig. 18). The first boundary is between the mosque and the core area (monitoring 20 M). The second boundary is between the core and the buffer zone (education, training-human settlements and research station or experiment 20 M). The last is between the buffer zone and transition zone (tourism and recreation 20 M) (Lasaponara et al., 2017) (Fig. 19).

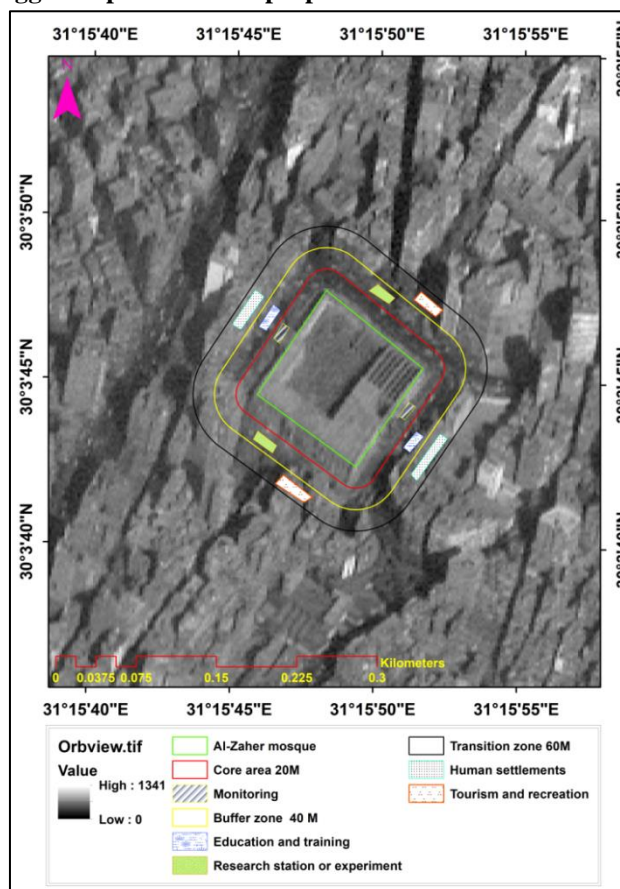
Fig.19 Suggested Zonation areas around the mosque by 3D Orbview satellite image.

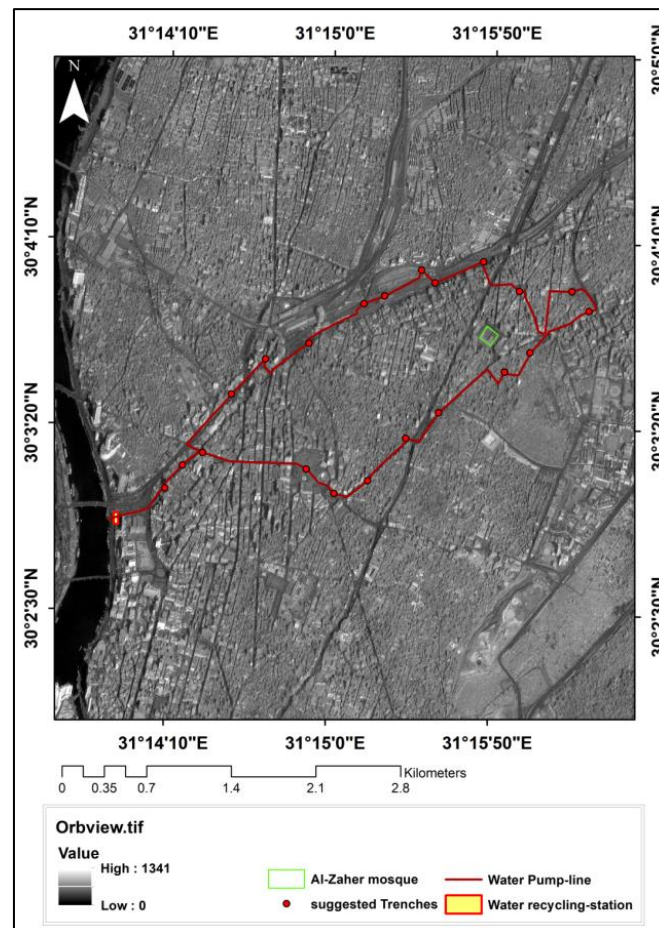
Fig.20 Proposed GIS-modeling around the mosque using Sentinel 2-A satellite image 2017 (RGB 4.3.2).

- Depending on the suggested points, Drainage system has been proposed to withdrawal the groundwater through digging up some of the trenches at spaced distances around the mosque. The suggested model is used to withdraw the wastewater slowly. The wastewater will be transferred for these trenches with tubes to water recycle station. Finally, this water can be used as pure in the Nile (Elfadaly et al. 2017) (Fig. 20).
