Evaluation The Effectiveness of Some Consolidants for Preservation of Limestone in Hathor Temple at Memhis, Egypt

Dr. Ahmed Ibrahim Manci

Conservation Dept., Faculty of Archaeology and Tourism Guidance, Misr University for Science & Technology, Egypt

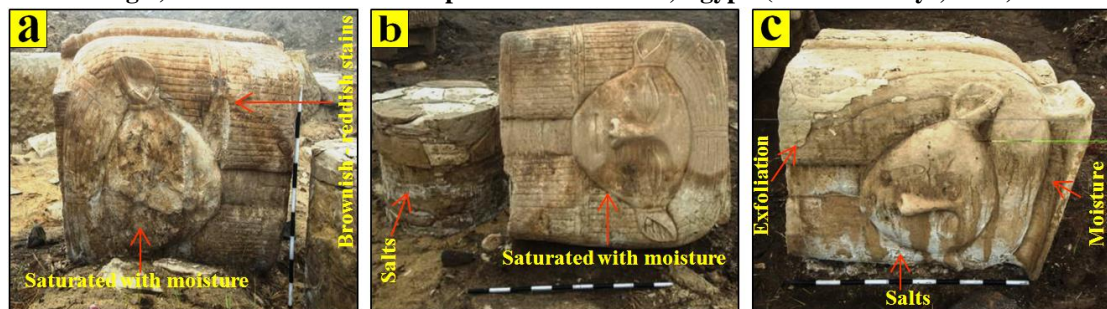
Fig.3a-g: Weathering forms of Hathor temple. a, b) downfall of Hathor column capital, being saturated with moisture, appearance of iron oxides as brownish stains. c, d) efflorescence of salts, exfoliation of stone surface as a result of sub efflorescence salts. e, f, g) saturated decorated columns with moisture and formation of hard crust of salts on the surface.

The limestone remains of Hathor temple showed fine inscriptions, which are very fragile and highly endangered, where the temple suffered from serious damages after discovering, due to being exposed to climate changes, and it was left without any treatment until now. During the inspection of the Hathor temple, different kinds of alterations and degradation phenomena were evidenced, such as exfoliation, crumbling to splitting, cracking, gaps, open joints, discoloration, staining from bird droppings, missing parts, erosion of stone surfaces, disintegration, salt efflorescence, accumulates of dirt, pits, biological attacks by plants, graffiti and scratches (Fig. 3- 5).

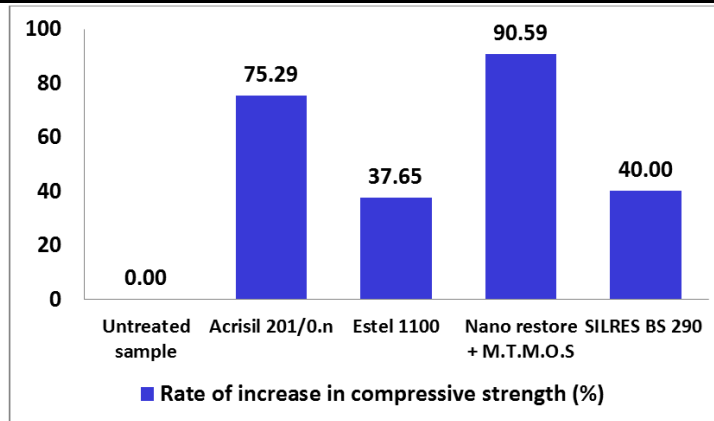
Fig. 10. The results of the compressive strength to the treated and untreated limestone samples.

Measurement of compressive strength of treated and untreated limestone samples were achieved. The results were reported in (Table. 2, Fig. 10). Where the all consolidants were used in this study, led to amelioration of compressive strength to the limestone samples by varying degrees .

By comparison, we can observe the differences in compression strength values for treated and untreated limestone samples; it was observed that the samples treated with nanocomposite (Nano restore + M.T.M.O.S) gave the highest average values of compressive strength, amount to 16.2 MPa, by an increase of 90.59 % with respect to untreated samples, which give average values a compressive strength amount to 8.5 MPa. This can be attributed to ability of nanocomposite to penetrate easily into porous matrix of treated limestone samples, depending on the small size of calcium hydroxide nanoparticles, and low viscosity of methyltrimethoxy silane polymer. In addition to the effect of carbonation process of calcium hydroxide nanoparticles, high reactivity, fast reactions in the treated zones, and high compatibility with limestone samples. Moreover, hydrolyzed of methyltrimethoxy silane polymer by water to form silanols, which then polymerize in a condensation reaction and form a polymer that increases the cohesion of the stone material, (Al-Omary. R, 2018, Mohammad A. Aldosari, 2017., Sierra-Fernandez. A, 2017). While the treated samples by (Acrisil 01/0. n) achieved the second level in a compressive strength, amount to 14.9 MPa, by an increase of 75.29 % with respect to untreated sample. This can be attributed to the good adhesion properties of acrylic polymers which resulted in their relatively high surface free energy, which confirmed that the addition of acrylic polymers to silicon polymers has a positive effect in increasing their mechanical properties, (Brus, J. and Kotlik, P, 1996). While the treated limestone samples by (SILRES BS 290) and (Estel 1100) achieved the third and fourth levels respectively, in terms of average values compressive strength.

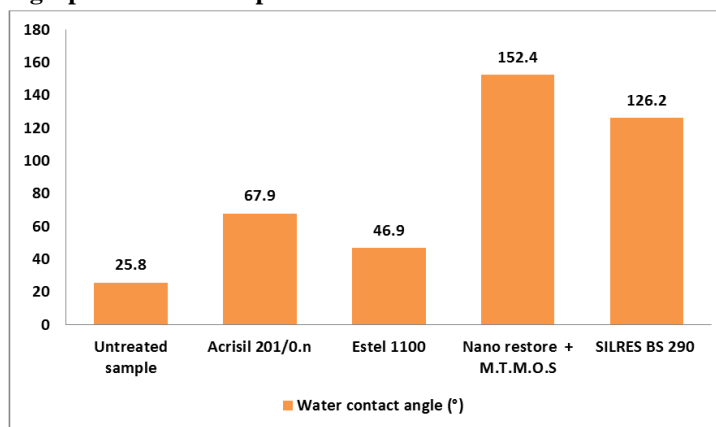
Fig. 14. Rates of static water contact angle to the treated and untreated limestone samples.

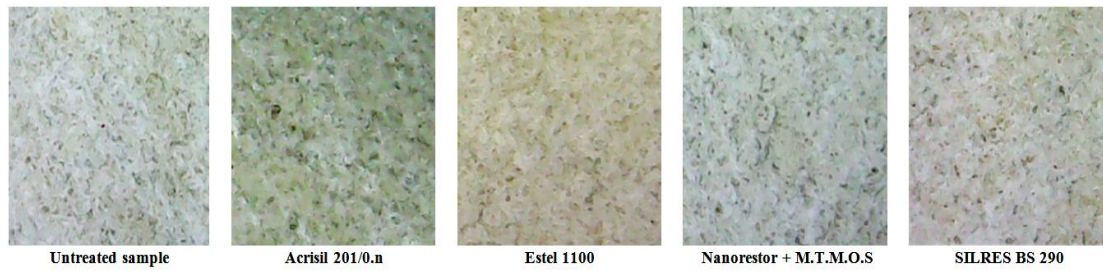
Fig.15. General appearance of the treated and untreated samples.

By the visual appraisal, it was found that (Acrisil 201/0.n) led to a significant darkness in the color of treated samples. While (Estel 1100) led to a slight yellowness of the treated samples. While nanocomposite (50% nanolim + 50% M.T.M.O.S) didn't have a noticeable effect on the color of the samples. But the (SILRES BS 290) led to very slight change in the color of the treated samples.

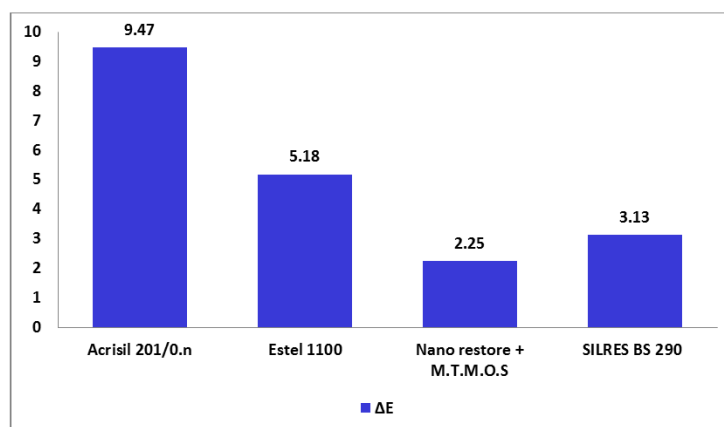
Fig .16. Results of the chromatic measurements of the treated samples.
