An experimental study for evaluating the efficiency of consolidated materials for limestone treatment.

Abstract:

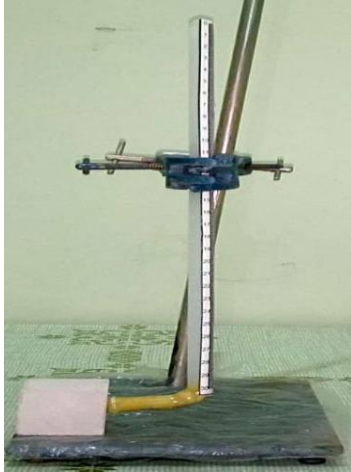
Fig.1 Showing the Meroviski consolidation process.

Two methods of reinforcement were used, the first was the Mirovski method[24], This method is based on the spread of the consolidation material within the impact in the semi-circular form, and the repetition of the application of previous operations can be strengthened large areas of the impact surface by the convergence and overlap of semi-circles, This method is based on the spread of the consolidation material within the impact in the semi-circular, the stone cube of the reinforcement material was followed up every hour and the results were recorded Fig.1-10, Tab.1, for consolidating cube stone with NANORESTORE, the consolidating process continued for 252 hours, where the cube continued to absorbed for the consolidating material up to 248 hours, and then the cube stopped from absorbing till four hours after that and the cube absorbed 50 mm of NANORESTORE, While the consolidating of Remmers KSE 300 E process continued for 23 hours, where the cube continued to absorb up to 19 hours, and then stopped about absorbing for four hours and the cube absorb 9 mm of Remmers KSE 300 E however the consolidating of SILRES BS 100 OH process continued for 100 hours, where the cube continued to absorb up to 98 hours, and then the cube stopped from absorbing for two hours and the cube absorbed 11.5 mm of SILRES BS 100 OH, while the process of consolidating stone cube did not succeed in with Paraloid B72 and Paraloid B44 materials and Paraloid B72 concentration 3% concentration Paraloid B44 concentration 3%, and Ca (OH)₂/polymer nanocomposites, as the acrylic polymers have blocked the sponge pores used in the tube nozzle, and when we measure the diameter of the dispersed treatment material Fig. 11, SILRES BS 100 OH achieved 27.5 mm, Remmers KSE 300 E achieved 24 mm and NANORESTORE achieved 18 but The process of consolidating stone, In the immersion method, the stone cube was left for 24 hours in the reinforcement material, Fig.2, Tab.1 and the result of reinforcement materials showed that the cube which treated with Nano restore absorbed 17.5 mm, and absorbed 10 mm from SILRES BS 100 OH and Remmers KSE 300 E, however, the stone cube absorbs 30 mm from Paraloid B72 concentration 3% but absorbed 20 mm from Paraloid B44 concentration 3%, and from Nanocomposite materials, the stone cube absorbed 20 mm from paraloid B72 concentration 3%), and Ca (OH)₂/polymer nanocomposites while the cube absorb 15 from Paraloid B44 concentration 3%, paraloid B44 concentration 3%), and Ca (OH)₂/polymer nanocomposites.

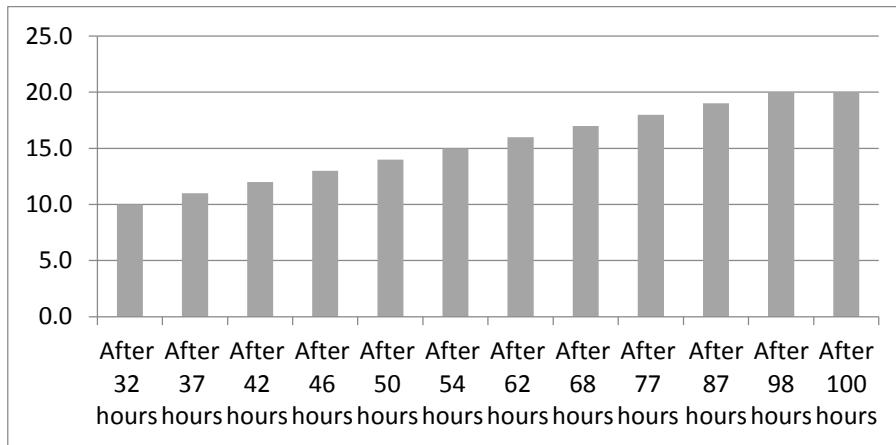
Fig. (9-10) shows the degree of absorbing of the stone cube with the material of SILRES BS OH 100.

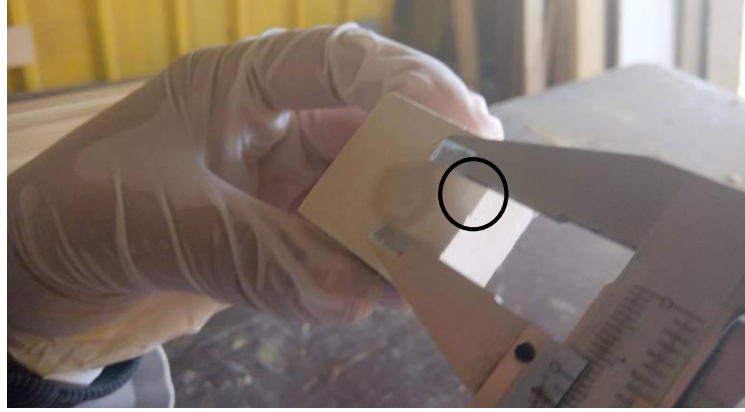
Fig. 11 Measurement of the diameter of the dispersed consolidation materials.

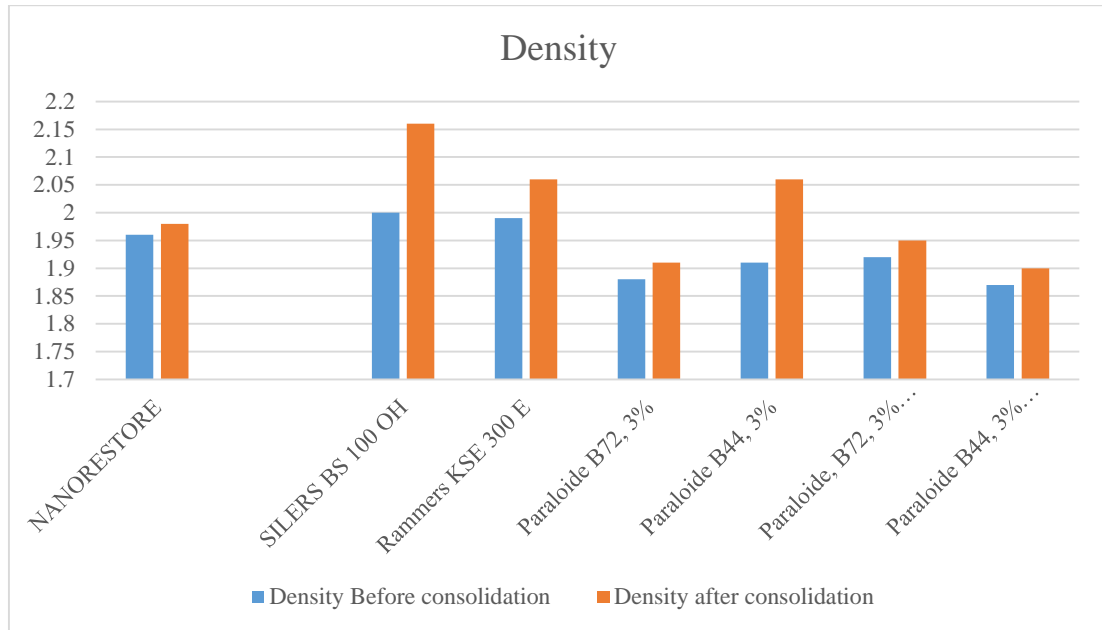
Fig.21 shows values of Density for untreated, treated limestone samples.

(3.5) Physical properties measurement The measurement physical properties was carried out before and after treatment, The values of Denisity, porosity and water absorbaton were recorded in **Table (4.5)**, Fig. 21,22.

• **Density values** were determined for the samples treated with different consolidating materials. The results showed that the density values of treated samples were increased compared to the non-treated samples table 3, Fig 12. SILERS BS 100 OH achieved the highest value of density 2.16 KG/CM³, followed by Rammers KSE 300 E and Paraloid B44

concentration 3% 2.06 KG/CM³, then NANORESTORE material achieved 1.98 KG/CM³, followed by (paraloid B72 concentration 3%), and Ca (OH)₂/polymer nanocomposites 1.95 KG/CM³, then Paraloide B72 concentration 3% achieved 1.91 KG/CM³ followed by (paraloid B44 concentration 3%), and Ca (OH)₂/polymer nanocomposites which achieved 1.90 KG/CM³.
